PROPERTY INSPECTION REPORT

Concerning: Vintage Avenue, Everytown, TX 76000
(Address of Inspected Property)

By: M Victor Sedinger, #7195 06/03/2008
(Name and License Number of Inspector) (Date)

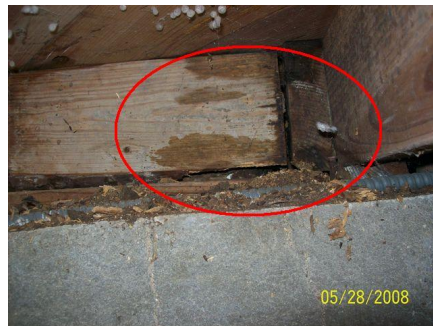
- **Recommend removal of wood and cardboard debris on the ground in the crawlspace. This condition is conducive to termite infestation.**
- **Water-damaged lumber was observed inside the crawlspace at the rim joist, northeast corner of the back porch.**

Damaged joist, back porch (from crawlspace)

- Observed a sag in the floor surface at the south end of the hall, at entry to southeast bedroom. This area appears to correspond with the rim joist water damage itemized in the "Foundations" section above.

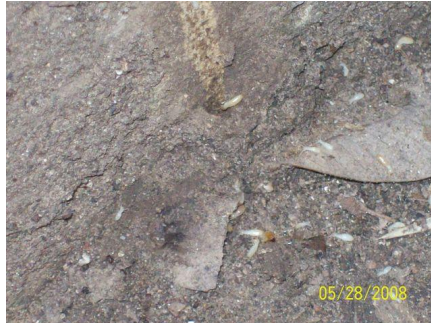
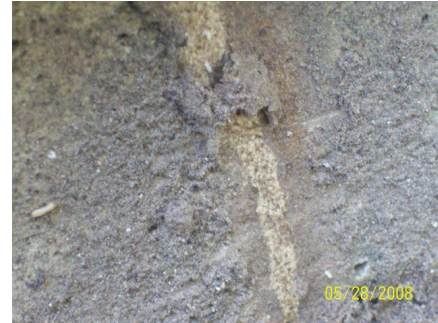
- **Inspector observed live termites at the stem wall, front wall of the house. Termites had built a mud tube from the grade soil up the stem wall to the stem wall and behind, into the wood siding. Inspector is a licensed Pest Control Technician, TPCL 13439, but Client had chosen not to have a wood destroying insect inspection and report performed on the property.**

Live termites at front wall of structure

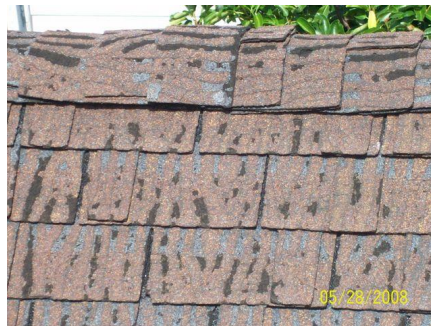
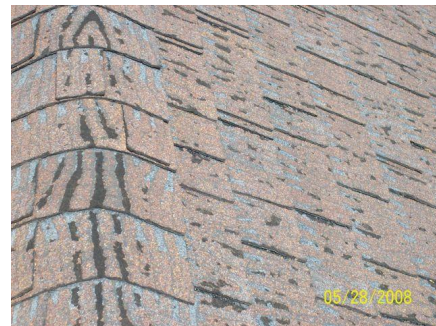
- Composition shingles on the roof appear to be type which has been considered defective by the industry. Inspector observed large-scale surface damage at the composition shingles, especially at the south- and west-facing slope exposures. A roofing specialist should evaluate the entire roof covering and report concerning any available recourse for replacement.

Observed large-scale surface damage at shingles, especially south and west-facing

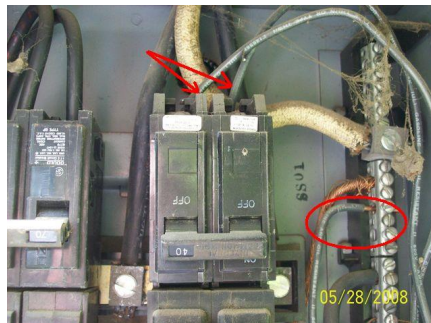
- Observed a 10- or 12-gauge wire connected to a 40-amp breaker in the exterior main panel. This appears to be a potential overcurrent hazard.
- A black wire is present at the neutral/grounding bus in the exterior main panel.
- Bushings are missing from the lower panel entry points in the interior main panel. Chafing of wiring insulation against metal panel can be hazardous.

Black wire at neutral bus & oversized breaker

Due to issues in this and the following section, Inspector recommends that a licensed electrician evaluate the electrical system, report and repair as needed.

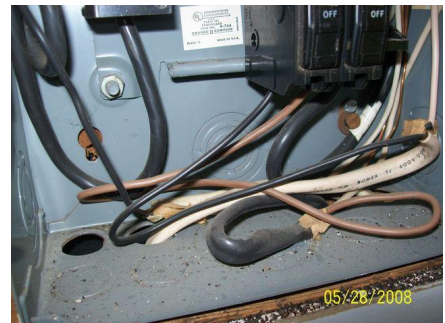
Bushings missing from panel entry points

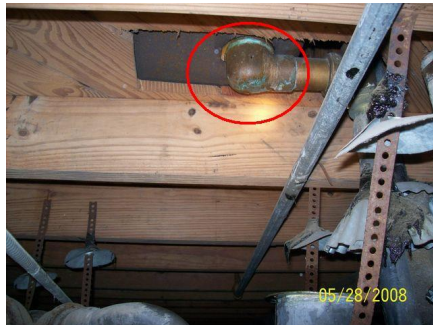
- Observed leaks in the crawlspace under the bathroom tub drain and at a waste pipe hub leading from the kitchen under the dining room.
- A barrel type drain trap was observed under the bathroom tub. These are considered obsolete plumbing drain fixtures.

Leak observed under bath tub drain

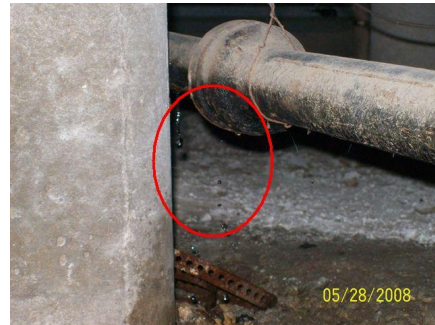
Leak under dining room floor (kitchen drain)
